Lake Management Plan for Muskellunge Lake, Vilas County, Wisconsin

July 2005

Prepared by **Steve McComas, Blue Water Science**
with contributions from **Wisconsin Department of Natural Resources**
and the **Muskellunge Lake Association**

Summary of the Lake Management Study

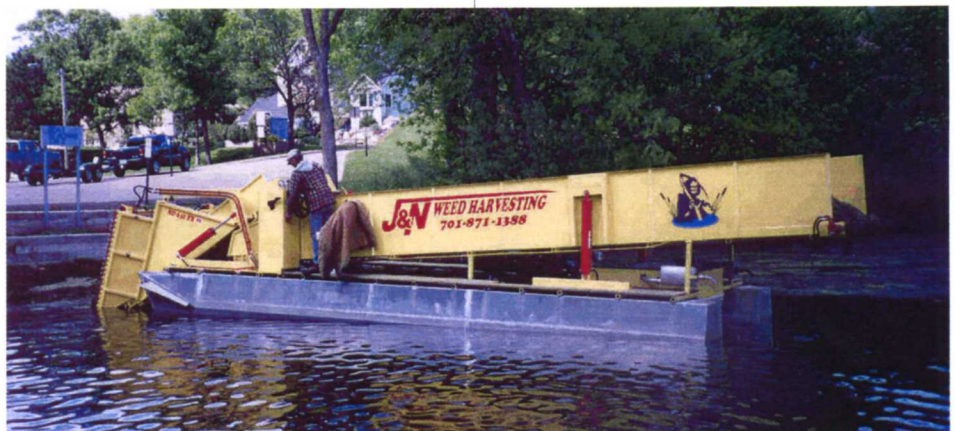
A mechanical harvester could be used to create cruising lanes through several areas of dense growth in Muskellunge Lake.

- Maintaining good shoreland conditions can sustain long-term shallow water plant communities. Ongoing shoreland maintenance and improvement will be important.
- Aquatic plant removal using manual methods is an option for maintaining an open area in front of your property. Mechanical harvesting is another option if channels out to open water are deemed necessary. However, only the minimum amount of plants needed to reduce navigational hindrances should be removed.

Winter aeration probably needs to continue indefinitely, unless winter sampling indicate oxygen levels can be maintained without it. A future project involves a fish and an aquatic plant manipulation in an attempt to improve water clarity. Increasing gamefish stocking and decreasing bluegill density by netting could restructure the fish community and result in better water clarity through a biomanipulation pathway. Maintaining channels through thick vegetation would give gamefish access to panfish and sustain bluegill control.
